Overlap Control Valve Sleeve Kits

MERCEDES 722.6 '99 & Earlier

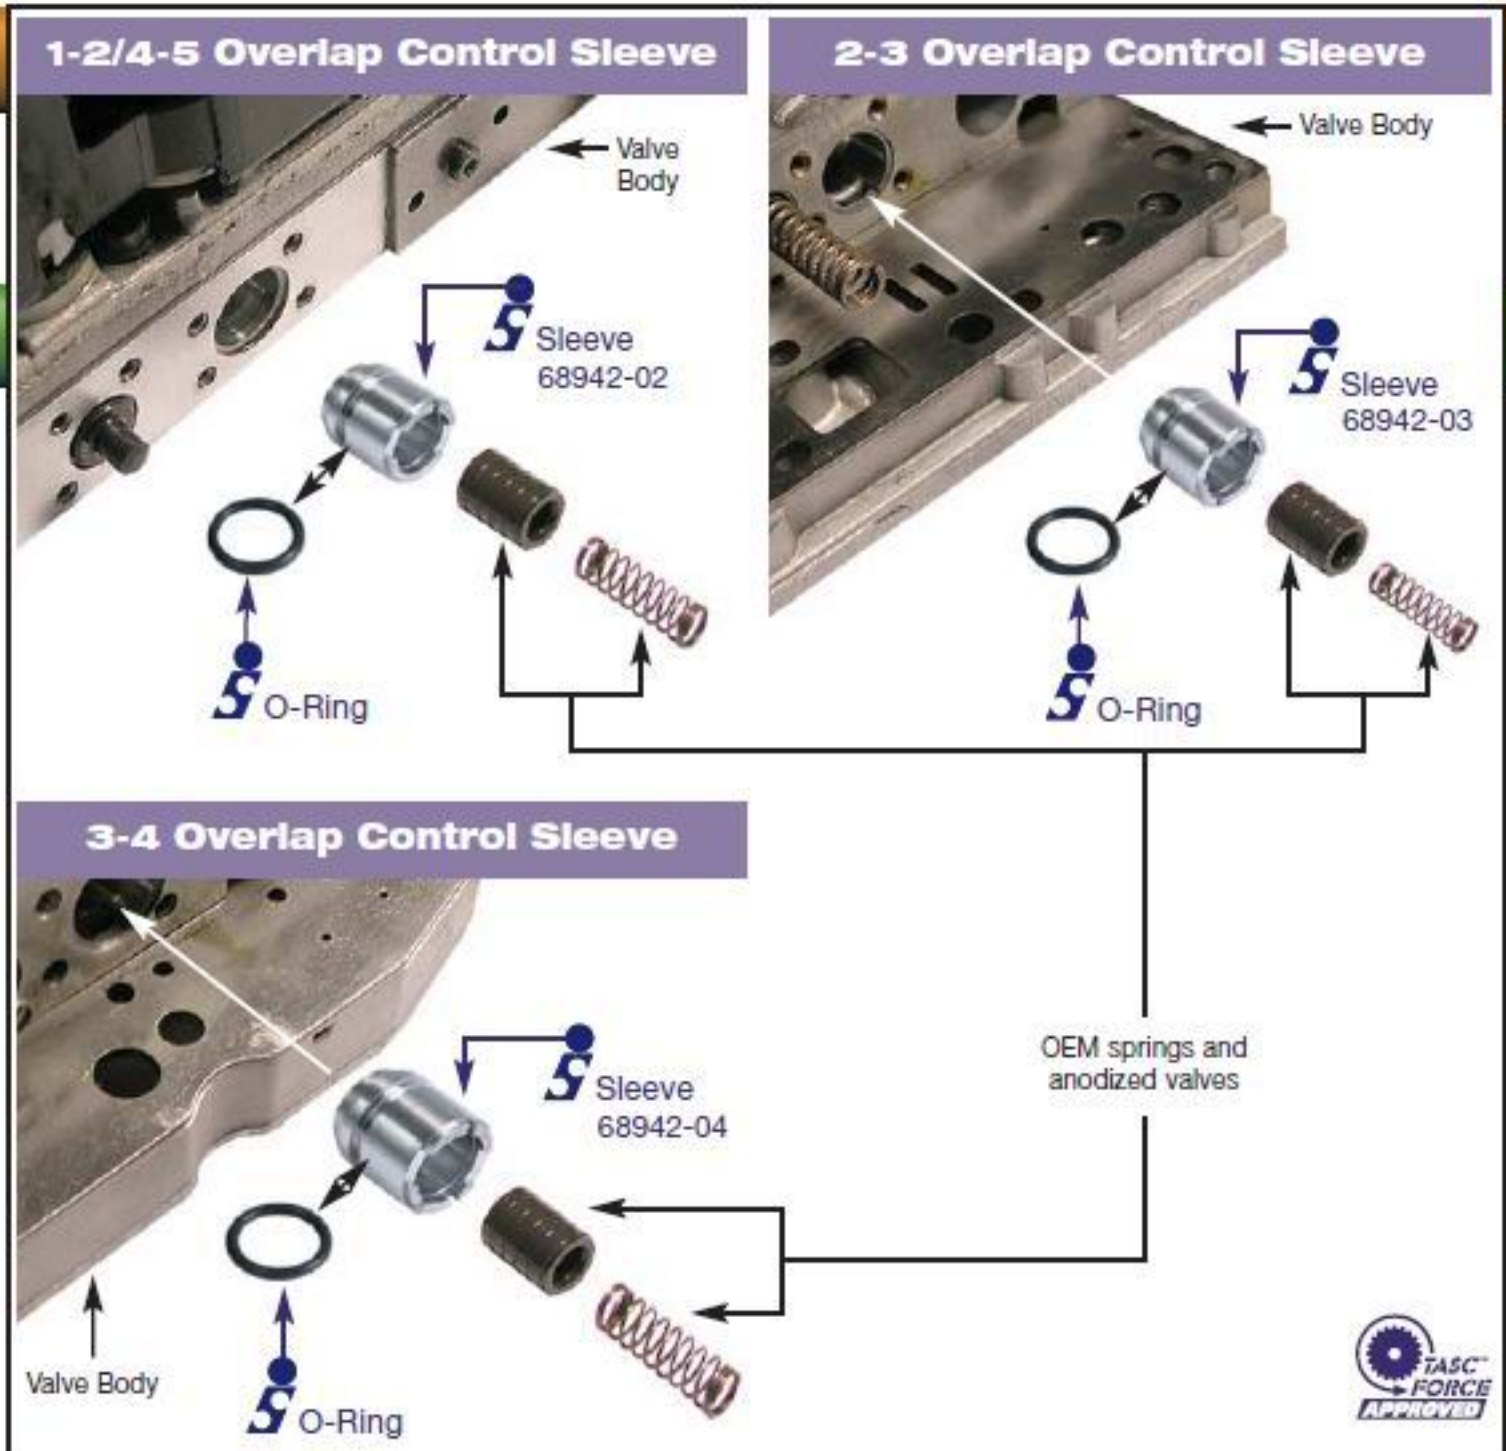
Harsh, bumpy or flare shifts

- Long shift and gear ratio codes

Wear at the 1-2/4-5, 2-3 and/or 3-4 overlap control valve sleeves allows modulating oil pressure to exhaust.

The 1-2/4-5, 2-3 and/or 3-4 overlap control valve sleeves wear, allowing modulated oil pressure to exhaust or oppose the shift and create numerous shift complaints. The highly wear-resistant Sonnax replacement sleeves restore necessary hydraulic control tolerances, and have external o-rings to provide additional positive sealing in the bore. The OEM springs and anodized valves can be reused.

These modulating sleeves position the valve for proper clutch feed. Sleeve kits correct the wear condition and restore control of clutch pressure apply or exhaust.

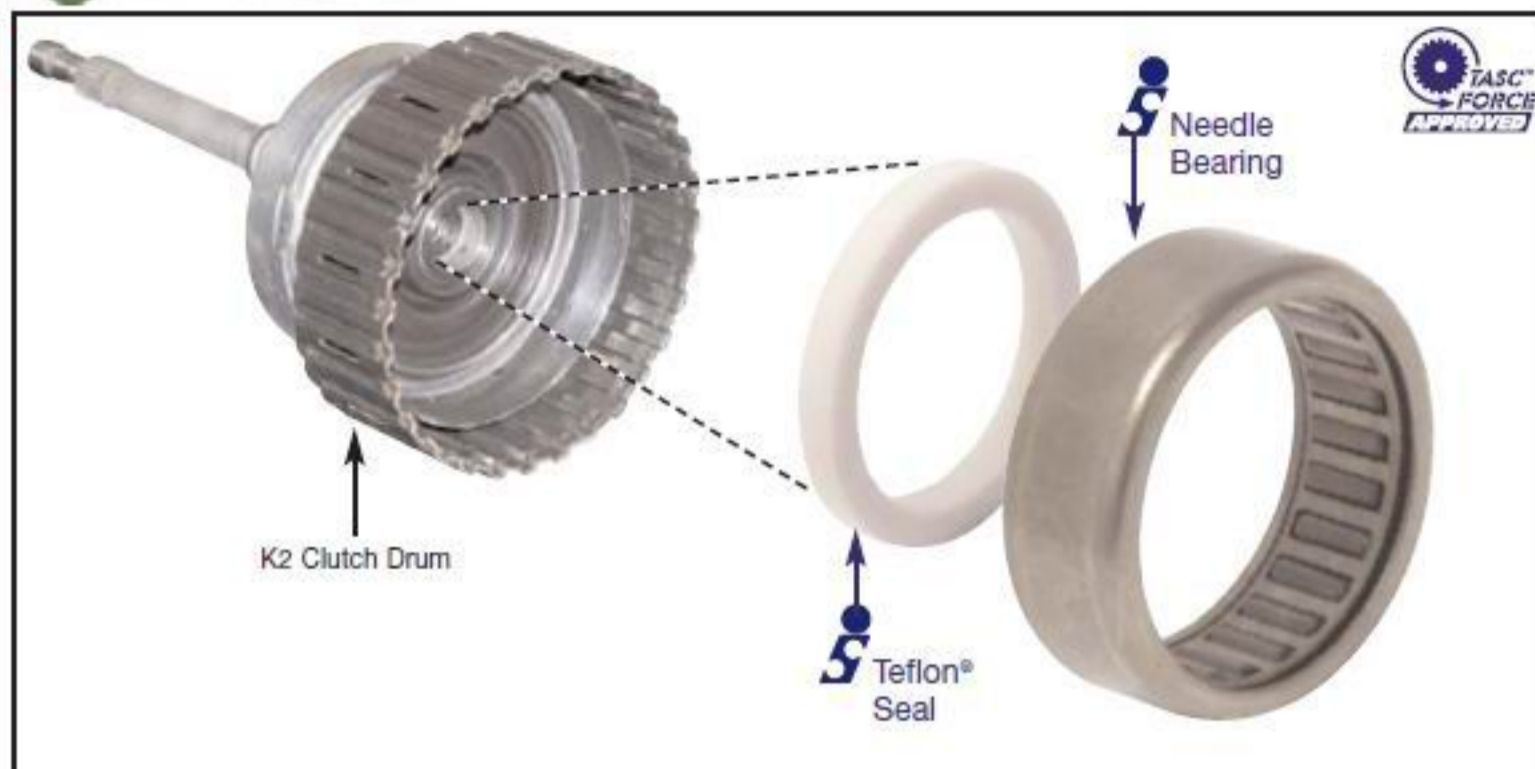
Bearing & Seal Kit
for K2 Clutch Drum

Premature planetary failure

Poor lubrication and bearing failure.

The Sonnax kit is a drop-in replacement that prevents costly planet failure.

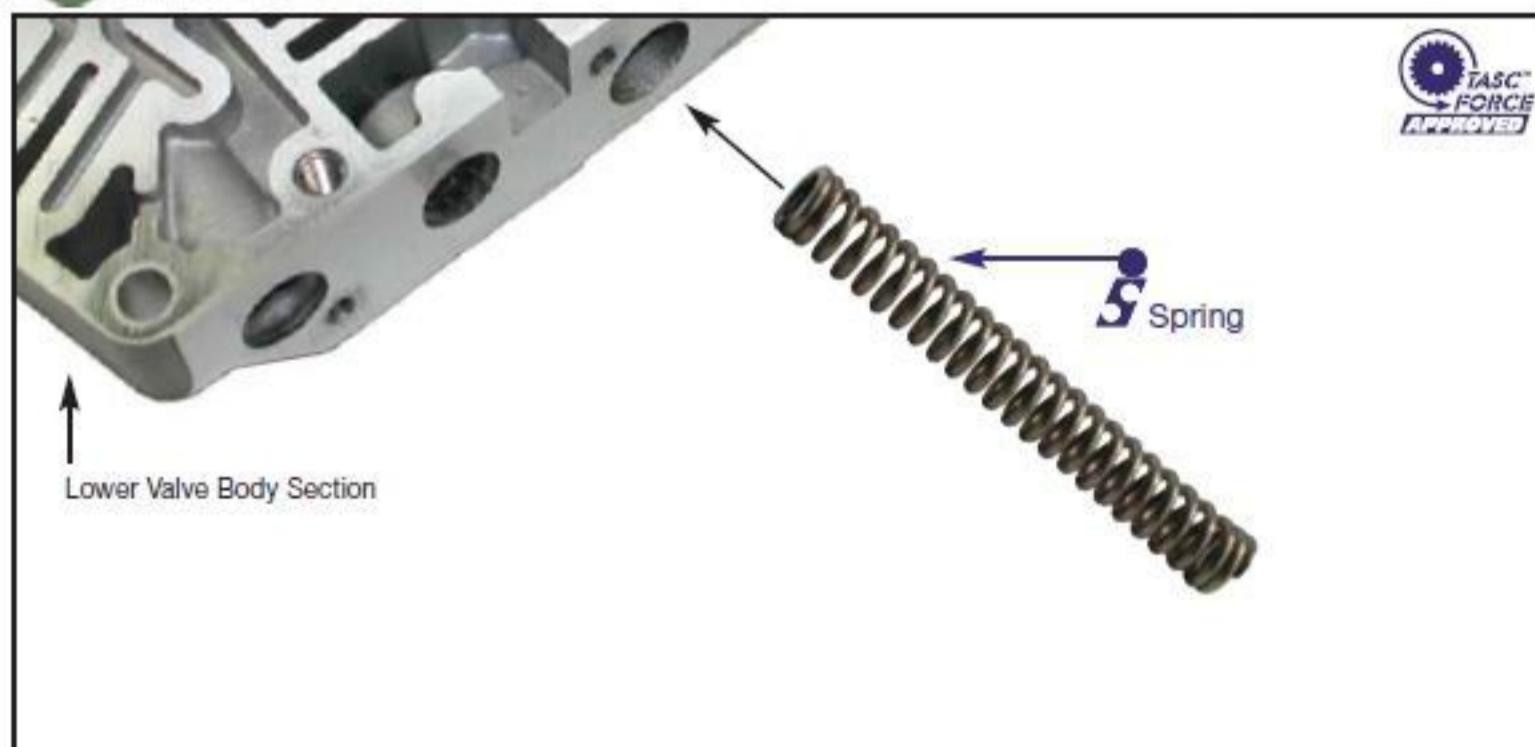
Solenoid Pressure
Regulator Spring

Delayed engagements

- Flared 2-3, 3-4, or 4-5 shifts

The solenoid pressure regulator valve spring breaks.

Replace the OEM spring with the more durable Sonnax spring.

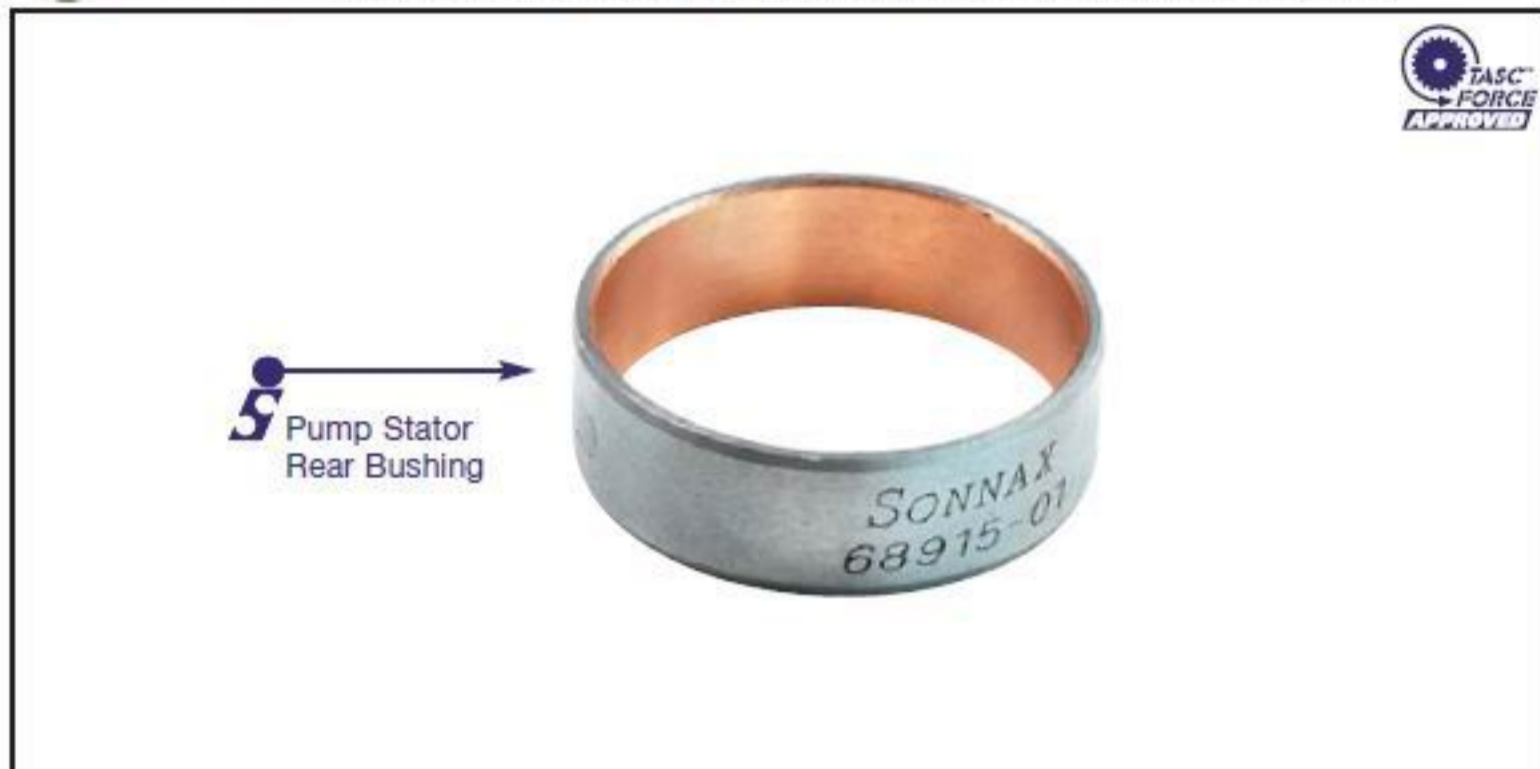
Pump Stator Rear Bushing

Normal wear damages bushing

Replacements are not available from OEM.

Sonnax precision bushing replaces the worn-out OEM pump/stator bushing, and is steel-backed with a copper alloy bearing surface for better wear resistance.

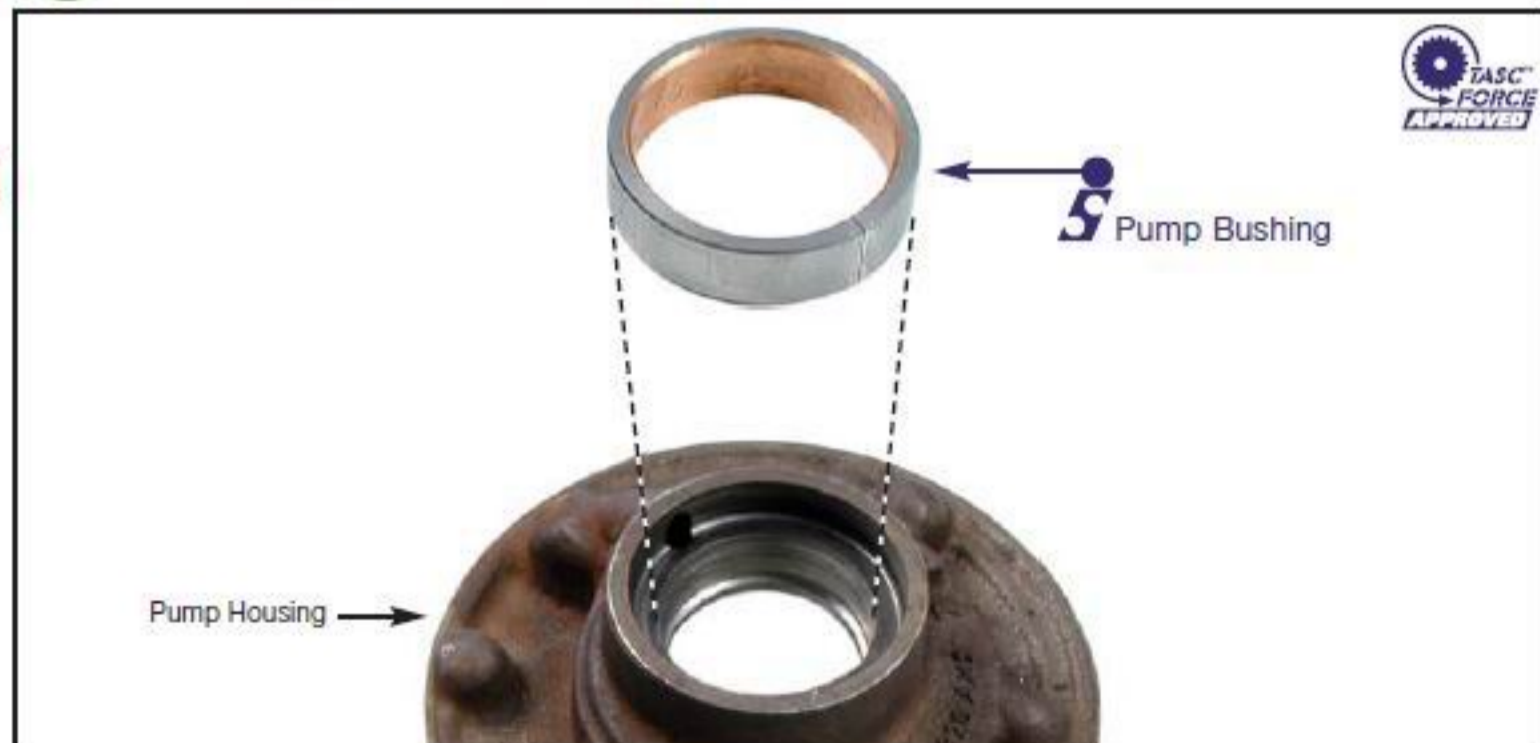
Pump Bushings

Pump leaks, worn or spun bushing, loss of pump core

Drive plate, converter pilot or hub run-out causes excessive load on the OEM bushing.

The Sonnax precision bushing or oversized finish-in-place bushing corrects wear and/or salvages damaged pumps.

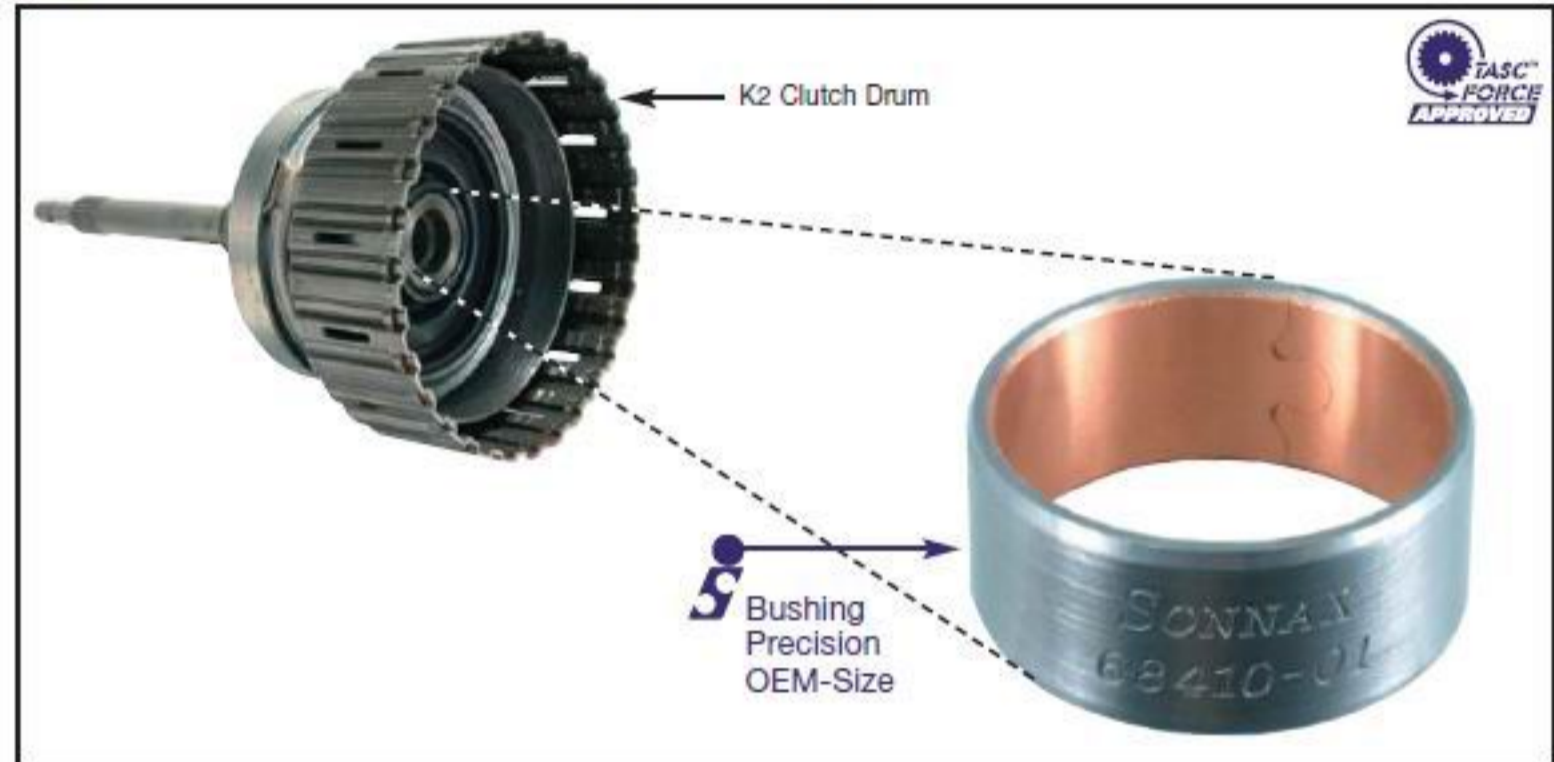
K2 Clutch Drum Bushing

K2 clutch drum bushing wear, loss of drum or output planet

Output shaft pilot wears the bushing and causes the planetary to run off center.

This bushing allows salvage of early-model drums with worn bushings and is a press-in fix requiring no machining.

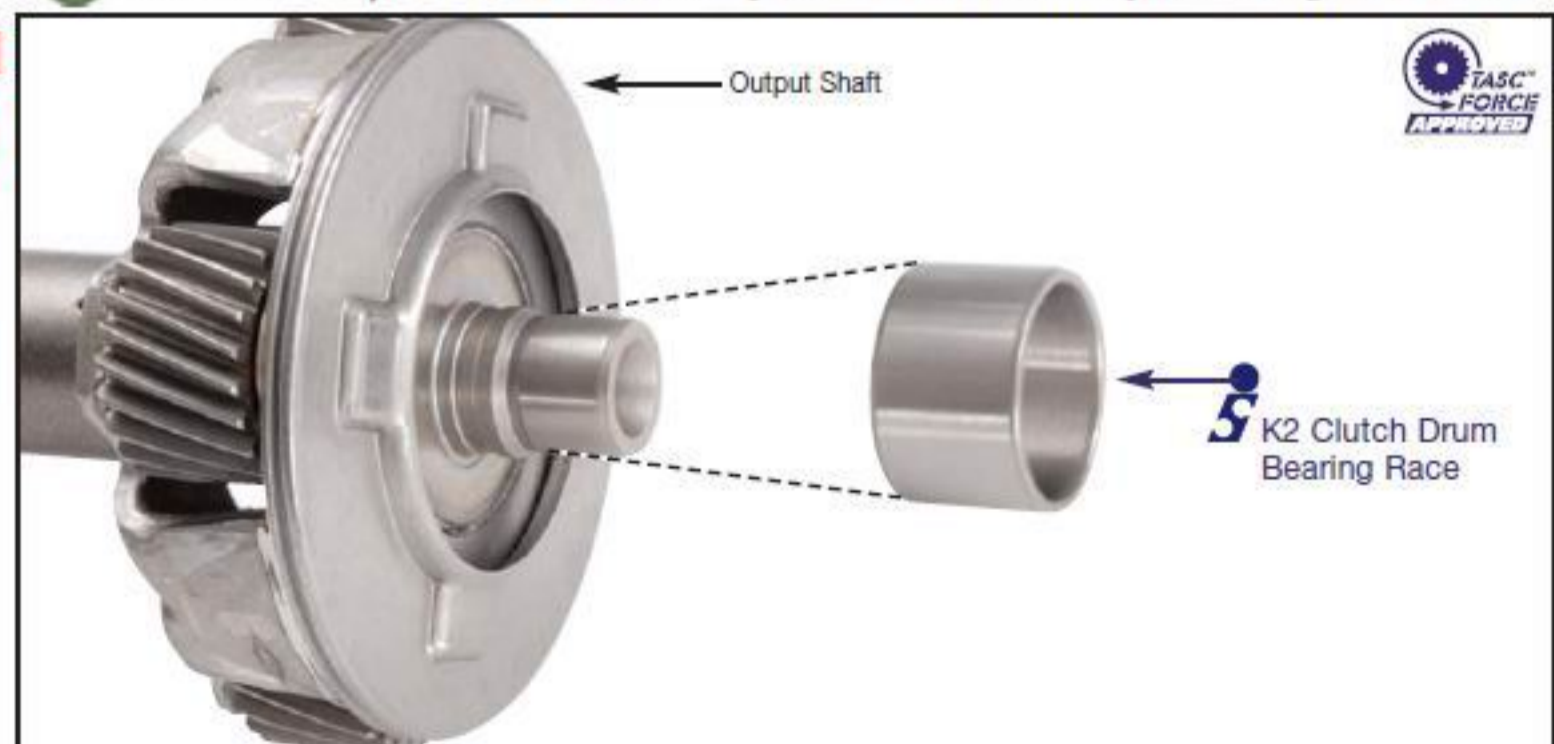
K2 Clutch Drum Bearing Race

Planet failure or bushing failure

- Early-style output shafts won't work with replacement bearing-style K2 drums

Bushing wear leads to lubrication loss, causing planetary failure.

This bearing race allows rebuilders to convert early-style output shafts for use with late-style K2 clutch drums. This provides a more durable repair, reducing risk of failure.
