Manual Valve

41750-03

KM 175, 176 & 177

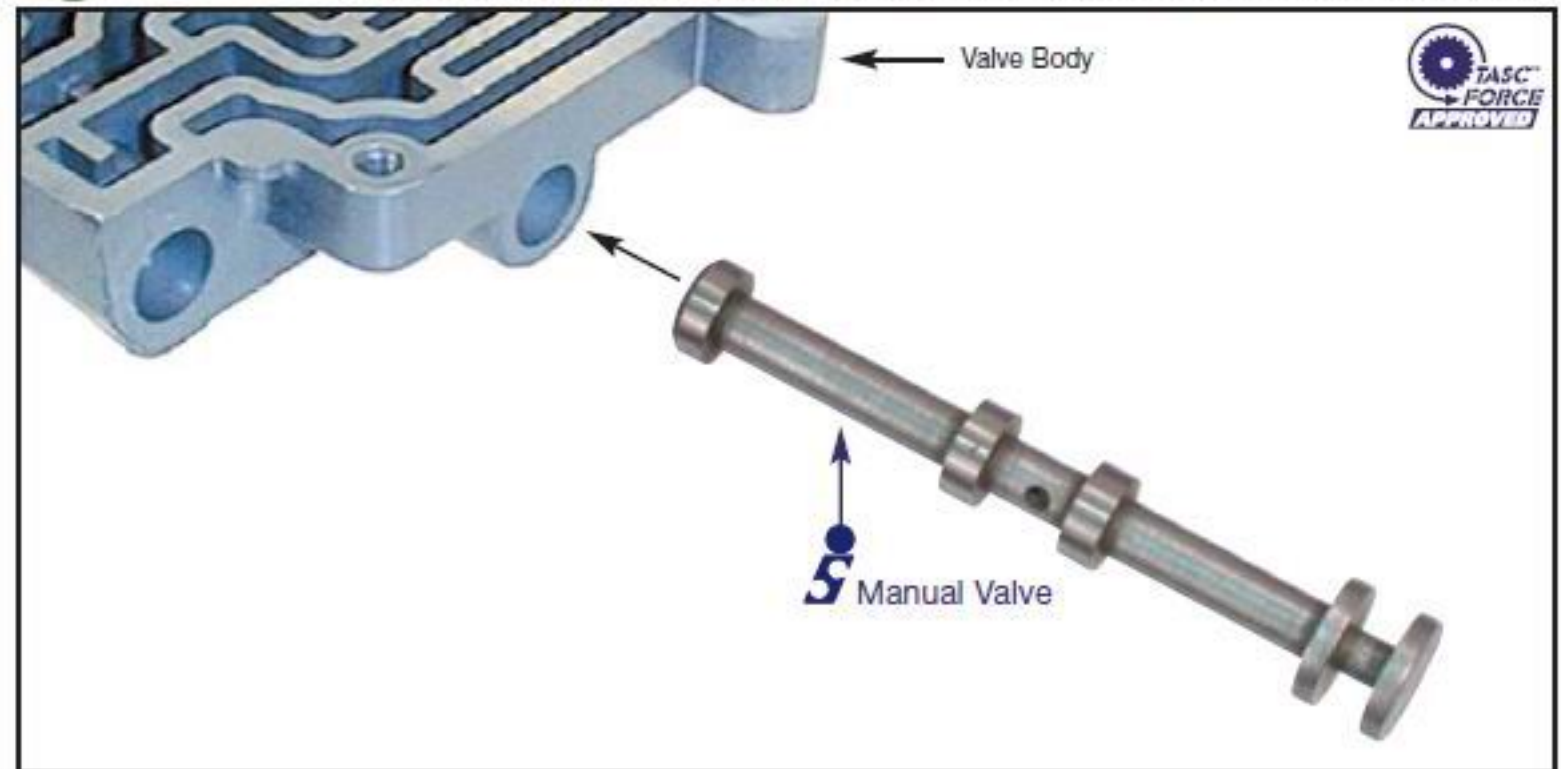
Delayed engagements, lube failures

CAUSE • No cooler flow in park • Pump or converter hub bushing spin-out and/or converter overheating
Line pressure exhausts and does not charge the converter when the selector lever is in park.

CORRECTION This redesigned manual valve blocks line circuit oil from exhausting to the sump, increases converter charge pressure in park, and also redirects exhaust flow and reduces sump cavitation.

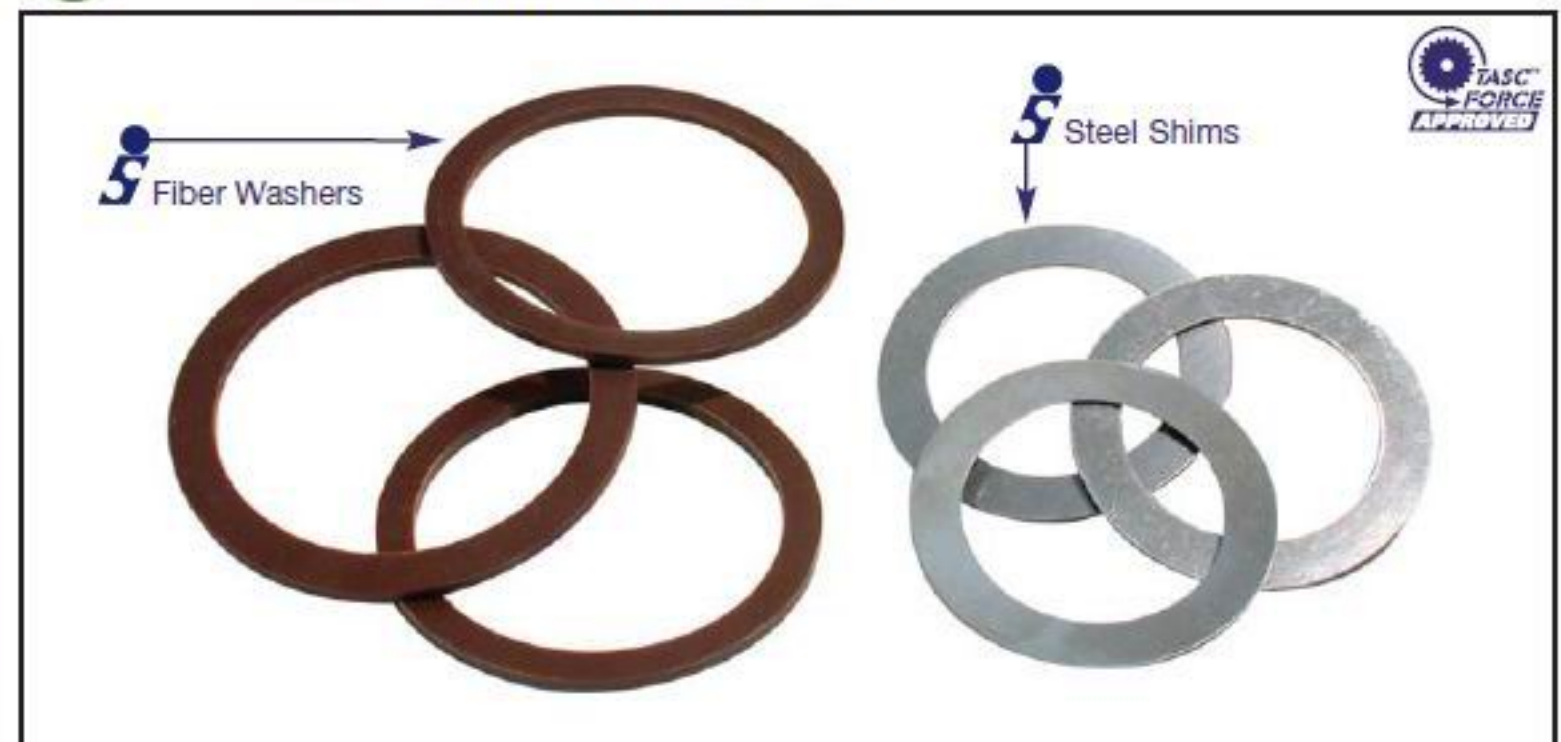
42000-01K

Flare 2-3 or 3-2 shift

CAUSE • Endplay set-up shims unavailable • Delayed forward or reverse • Excessive endplay
Lack of a shim to lift the gear train allows for excessive clutch drum travel. Placing excessive shims between pump & drums reduces sealing ring contact & results in clutch circuit oil loss.

CORRECTION This shim kit includes seven fiber washers for pump/drum set-up and six steel shims for supporting the rear/forward clutch drum.

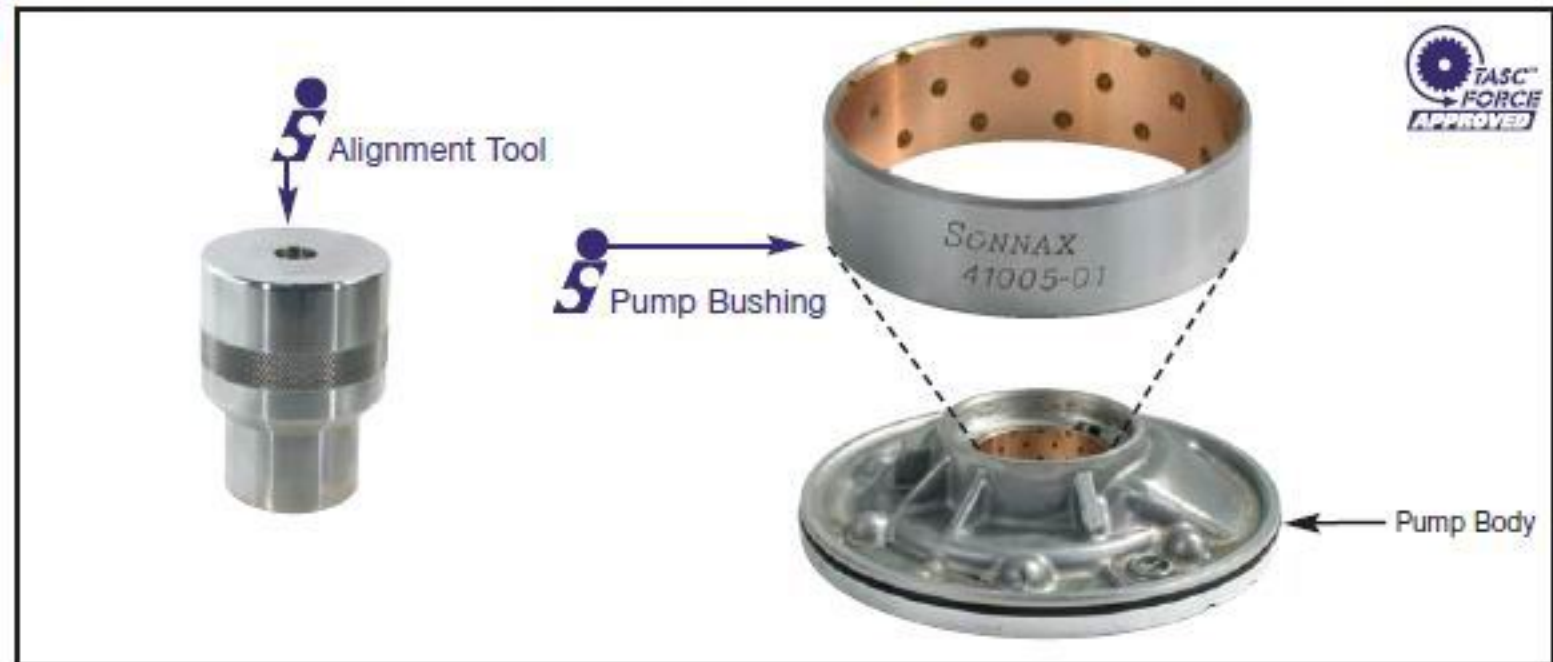
COMPLAINT**Seal leakage, pump noise**

• Bushing wear

The bushing wears through normal operation and replacements are not available from OEM.

Sonnax offers a precision steel-backed, ball-indented bushing to restore operational clearances, and a pump alignment tool to correctly reassemble the pump halves.

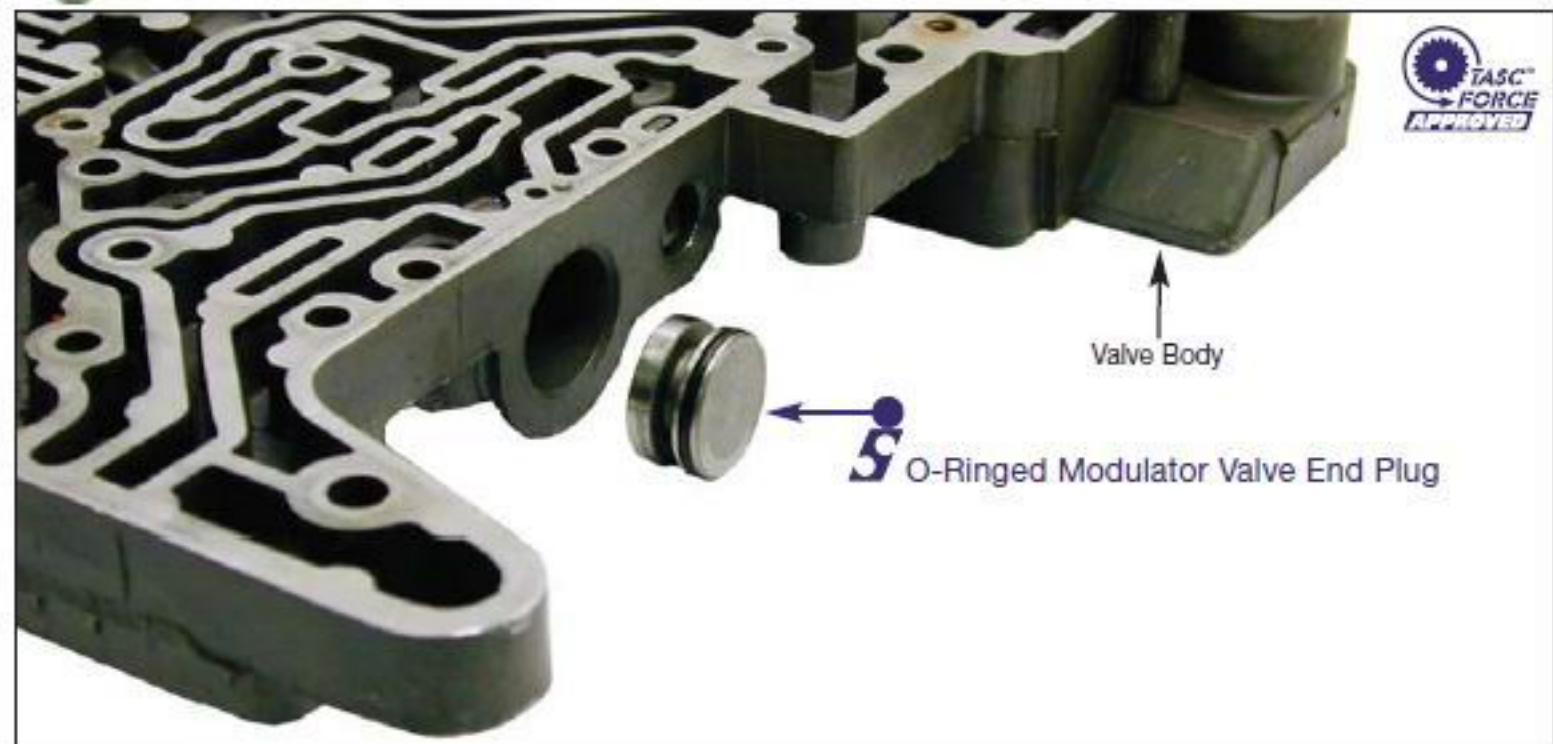
**BW-T65/66, BW-T35****COMPLAINT****Uncontrollable shift timing**

• Loss of governor pressure • Insufficient line rise • Forward clutch failure

Governor oil leakage at the throttle modulator valve end plug due to wear.

Use this replacement o-ringed modulator end plug to prevent valuable oil leakage.
